**Flood Control Project Maintenance
Levee Inspections**

Fall 2018 Levee Maintenance Deficiency Summary Report

**Flood Control Project Maintenance
Levee Inspections****LMA District Cover Sheet****Fall 2018 Levee Inspection Results****Reclamation District No. 0563 Tyler Island**

Reclamation District No. 0563 Tyler Island

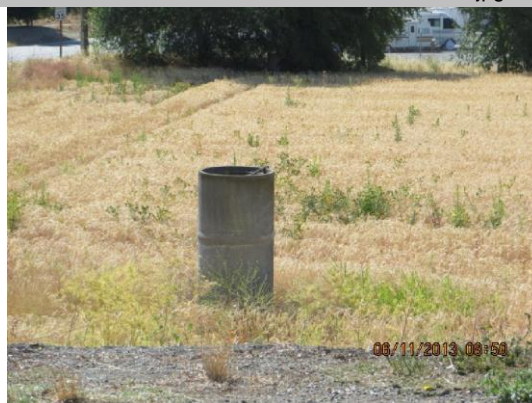
Photo 1 of 3 : UCIP_FA_2018_52739_24503.jpg

Comment Code						
Inspector Comment						
FS_ID:52739 DS_ID:20199 EP_NO: N/A Repair Type: Non-Urgent Crossing Status: Indicator Found UCIP Comments: 07/13/2018 Unable to locate the pipe. Only standpipe found on LS. (O.Yakimov-DWR UCIP)6/11/2013 Need to determine disposition of pipe. Was it abandoned properly? FIELD_STRUCT_DESC: 10-inch steel irrigation pipe through the levee, at an unknown depth. 36-inch concrete standpipe at the landside (LS) toe. Unable to locate pipe, 06/11/2013. [Additional Reference(s): USACE Sacramento O&M Manual 103, June 1954, (Station ""L"" 6+39), listed as a 1-inch pipe and a 36-inch pipe]. FS Date: 7/13/2018 9:06:44 AM

36-inch concrete standpipe on LS toe.

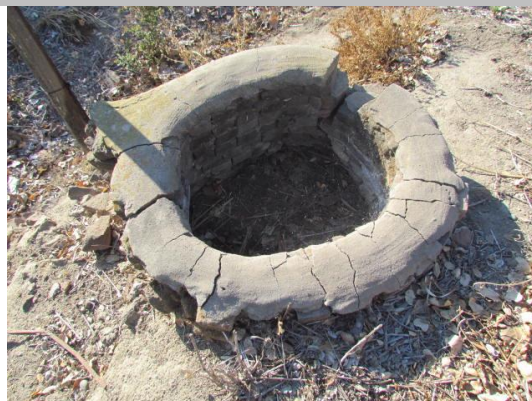
Photo 2 of 3 : FA_2018_RD0563_210_10_20180925_00007.jpg

Looking southeast at fire pit on landward slope.

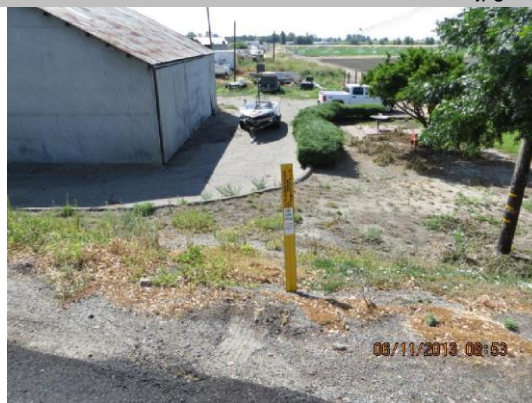
Photo 1 of 3 : UCIP_FA_2018_52740_24505.jpg

Comment Code						
Inspector Comment						
FS_ID:52740						
DS_ID:20129						
EP_NO: 3448						
Repair Type: Non-Urgent						
Crossing Status: Indicator Found						
UCIP Comments: 07/13/2018 Gas pipeline crossing sign found on LS slope, and monitoring well on levee crown. (O.Yakimov-DWR UCIP)6/11/2013 Sign on waterside slope should be cleared of vegetation.						
FIELD_STRUCT_DESC: 4.5-inch steel gas line through the levee, 4 feet below the crown and across the channel. Large warning sign on the waterside (WS) slope. (Permit No. 3448, 1960 - Pacific Gas and Electric Company [PG&E]). [Additional Reference(s): DWR Levee Log, 2005].						
FS Date: 7/13/2018 9:16:16 AM

Gasline marker on LS shoulder.

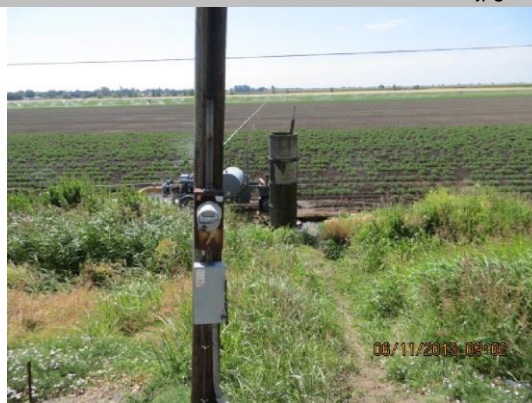
Photo 1 of 3 : UCIP_FA_2018_52741_24508.jpg

Comment Code						
Inspector Comment						
FS_ID:52741 DS_ID:20130 EP_NO: 11218 Repair Type: Non-Urgent Crossing Status: Found UCIP Comments: 07/13/2018 Electrical conduit that is attached to the pipe on WS fell appart at several locations. LS and WS slopes are heavily vegetated. (O.Yakimov-DWR UCIP)06/11/2013 Pipe leaking at various points on WS berm. Failure on berm may indicate potential for failure within the levee. Good candidate for video inspection. (W.Wylie-DWR) FIELD_STRUCT_DESC: 12-inch steel irrigation pipe through the levee, 5 feet below the crown. Walkway to pump on pile structure in stream. Siphon breaker in a 24-inch corrugated metal pipe (CMP) riser on the waterside (WS) shoulder. 1-inch air and vacuum valve and a 15-foot-tall by 36-inch-diameter concrete standpipe at the landside (LS) toe. (Automatic Board Order (ABO) issued as Permit No. 11218, 1975 - Fong Yock Yee). [Additional Reference(s): DWR Levee Log, 2005. USACE Sacramento O&M Manual 103, June 1954, (Station ""L2"" 196+67.8)]. FS Date: 7/13/2018 9:38:39 AM

JP on LS slope with 36-inch concrete standpip on LS toe.

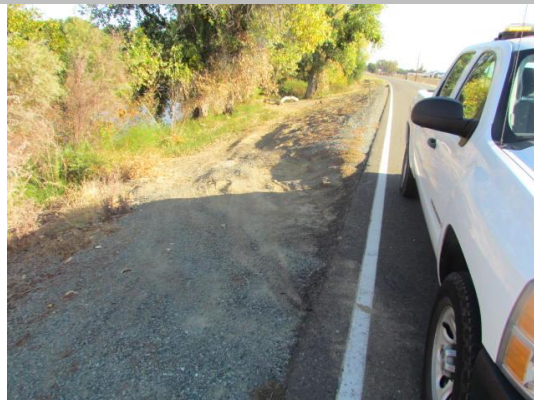
Photo 1 of 1 : FA_2018_RD0563_210_34_20180925_00018.jpg

LM Start	0.53	Rating **	M	Issue No.	34
LM End	0.53	Issue Type +	Ma	Location *	WS
Category	Earthen Levee			GPS Latitude/Longitude	
				Start	End
Item	Slope Stability			38.229232°	38.229232°
				-121.523538°	-121.523538°
DWR ID	DWR_RD0563_01_f_2018_34				
Comment Code					
S3 : Repair the levee slope damaged by vehicle traffic and prevent access where possible.					
Inspector Comment					
Slope damage is due to vehicle traffic.

Looking northwest at slope damage caused by vehicle traffic.

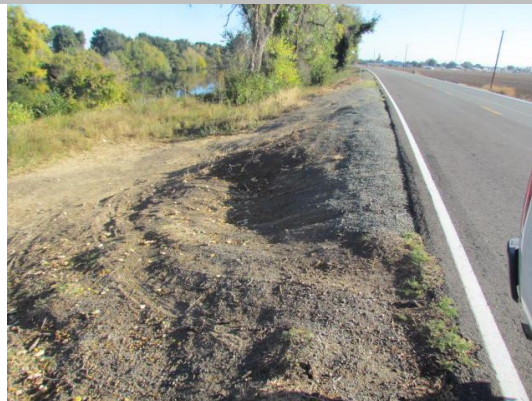
Photo 2 of 2 : FA_2018_RD0563_210_143_20180925_00101.jpg

LM Start	0.56	Rating **	M	Issue No.	143
LM End	0.56	Issue Type +	Ma	Location *	WS
Category	Earthen Levee			GPS Latitude/Longitude	
				Start	End
Item	Slope Stability			38.228930 °	38.228930 °
				-121.523935 °	-121.523935 °
DWR ID	DWR_RD0563_01_f_2014_143				
Comment Code					
S3 : Repair the levee slope damaged by vehicle traffic and prevent access where possible.					
Inspector Comment					
Slope damage due to vehicle traffic.

Looking northwest at slope damage on waterward slope.

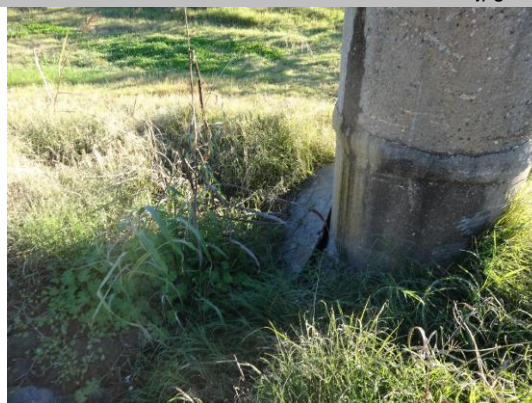
Photo 2 of 3 : UCIP_FA_2018_52731_76820.jpg

FS_ID:52731
DS_ID:20131
EP_NO: 11203
Repair Type: Urgent
Crossing Status: Found
UCIP Comments: 07/13/2018 Dense vegetation on LS slope limits visibility. Crossing remains "Urgent" due to unknown condition of the pipe section through the levee. (O.Yakimov-DWR UCIP) 03/08/2018 LS pipe section replaced however, unable to determine the condition of the pipe section through the levee. LS levee section disurbed and has not been repaired. Crossing remains Urgent due to the unknown condition of the pipe section through the levee. (O. Magana - DWR UCIP)12/02/2016 Same as last inspection signs of leak are still present on both LS and WS. Recommend internal inspection of the pipe integrity though the levee to determine cause of depression on levee (either leak or poor compaction). Pipe debris previous noted on WS has been removed. (O. Magana - DWR UCIP)06/11/2013 Signs of leak in pipe at levee slope on both LS and WS where pipe enters levee. Moist soil at LS toe indicates possible internal leak. Evidence of recent pipe repair on WS. Pipe debris on WS toe should be removed. (W. Wylie - DWR UCIP)

Minor leaks visible on concrete standpipe.

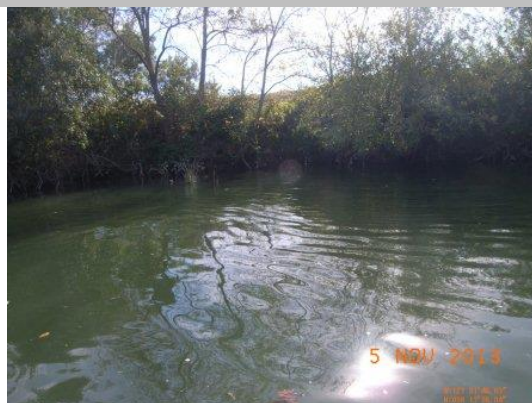
Photo 1 of 1 : FA_2018_RD0563_210_70_20181023_00227.jpg

LM Start	0.92	Rating **	M	Issue No.	70
LM End	1.11	Issue Type +	Ma	Location *	WS
Category	Supplemental			GPS Latitude/Longitude	
				Start	End
Item	2017 USACE Erosion Survey, DRAFT			38.225660 °	38.227157 °
				-121.527556 °	-121.530432 °
DWR ID	DWR_RD0563_01_f_2018_70				
Comment Code					
Inspector Comment					
2017 Site ID: GEO 11.0 L					
Status: Eroding					
2017 Field Notes: Increased toe erosion, slumping, boat wake erosion, and revetment failure near downstream end. Site extended upstream.					
Site History: 2011 - Short sections of eroding bank at the waterline and holes in toe of levee. 2012 - Site extended upstream. 2013 - Erosion pockets filled with an insufficient amounts of revetment. 2016 - Fresh erosion observed.

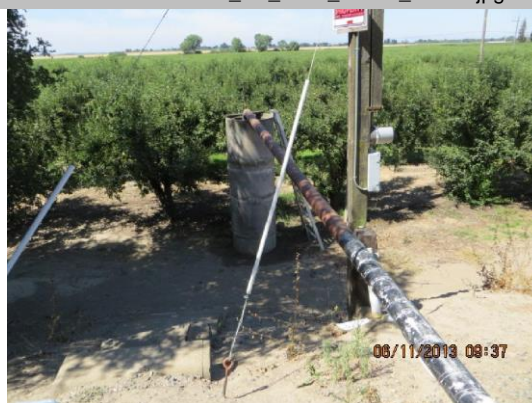
Photo 1 of 3 : UCIP_FA_2018_52744_24517.jpg

Comment Code					
Inspector Comment					
FS_ID:52744 DS_ID:20132 EP_NO: 11210 Repair Type: Non-Urgent Crossing Status: Found UCIP Comments: 07/13/2018 Water pump is running, leak thru pump seal is detected. Pipe on WS has been partially replaced with a new pipe to pumphouse. Remaining part of old pipe needs to be abandoned properly. (O.Yakimov-DWR UCIP)06/11/2013 Pipe does not have sufficient cover at crown. (W.Wylie) FIELD_STRUCT_DESC: 6-inch irrigation pipe of an unknown material through the levee, 3 inches below the crown. Pump and gate valve in pump house on the waterside (WS) slope. Service pole on the landside (LS) slope. (Automatic Board Order (ABO) issued as Permit No. 11210, 1975 - Leland O. Hanson). 1-inch polyvinyl chloride (PVC) electrical conduit through the levee at the same location, at an unknown depth. [Additional Reference(s): DWR Levee Log, 2005. USACE Sacramento O&M Manual 103, June 1954, (Station ""L"" 43+91.9), listed as a 14-inch pipe]. FS Date: 7/13/2018 1:28:34 PM

6-inch pipe and concrete standpipe on LS. Electrical conduit runs parallel to pipe to pumphouse on WS.

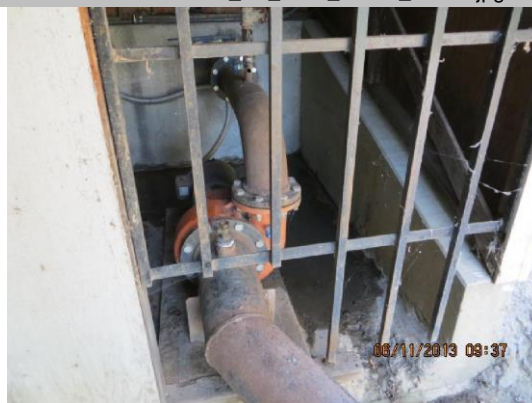
Photo 3 of 3 : UCIP_FA_2018_52744_24519.jpg

Butterfly valve, vent and pump in pumphouse on WS shoulder.

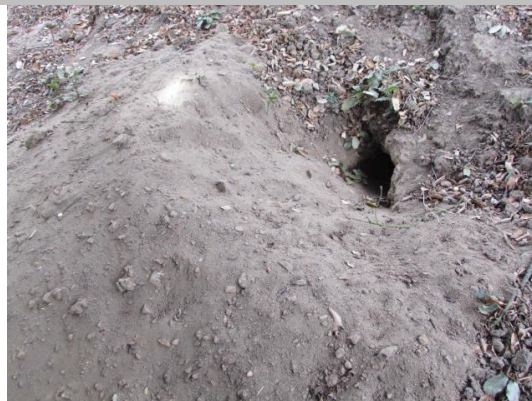
Photo 1 of 1 : FA_2018_RD0563_210_153_20180925_00107.jpg

Looking at typical view of several rodent holes on landward slope.

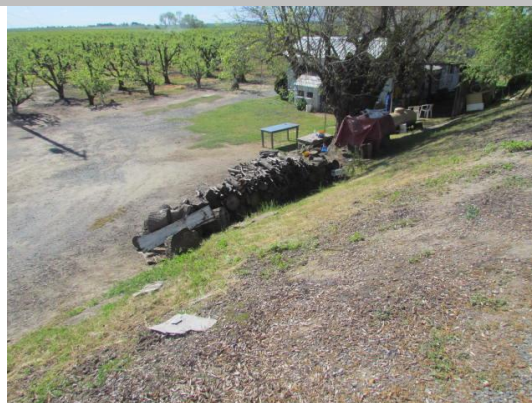
Photo 2 of 2 : FA_2018_RD0563_210_134_20180925_00092.jpg

Looking southeast at firewood at landward toe. (Spring 2016)

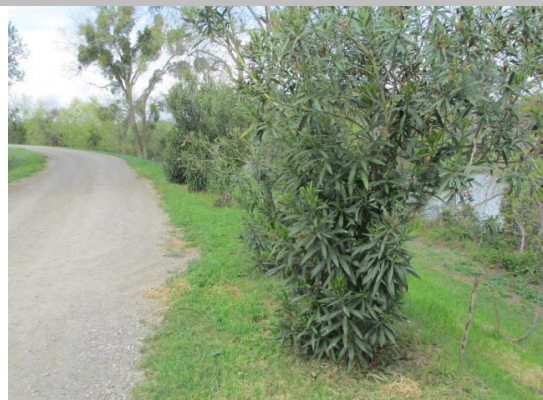
Photo 4 of 4 : FA_2018_RD0563_210_142_20180925_00099.jpg

Looking southwest at oleanders on waterward shoulder.

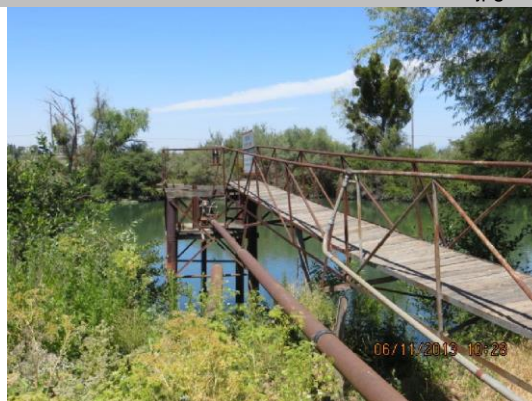
Photo 1 of 3 : UCIP_FA_2018_52751_24537.jpg

Pump on pile structure with walkway structurally failing. WS berm.

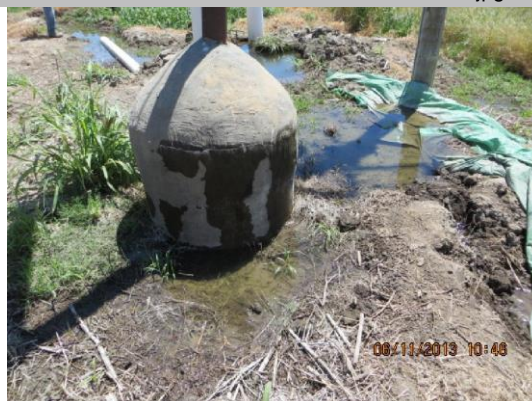
Photo 3 of 3 : UCIP_FA_2018_52732_24539.jpg

Leaks around standpipe on LS toe.

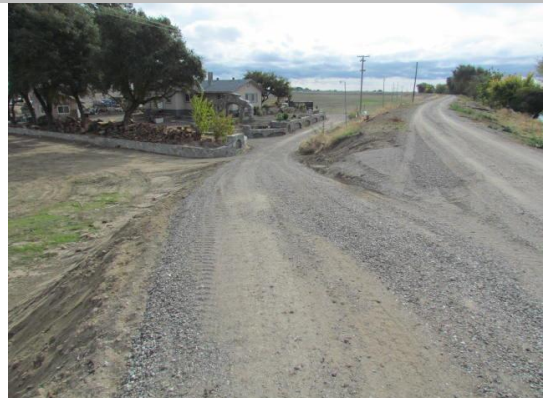
Photo 2 of 2 : FA_2018_RD0563_210_80_20180925_00050.jpg

Looking southeast at unauthorized ramp on landside slope.

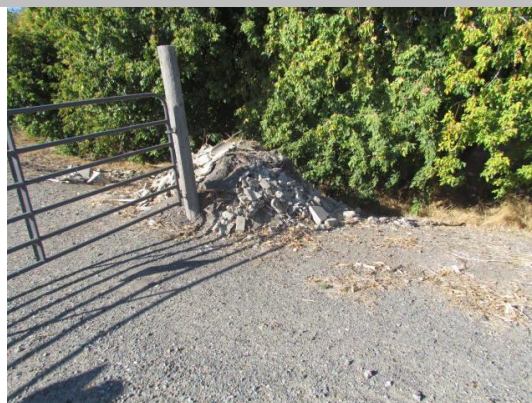
Photo 1 of 2 : FA_2018_RD0563_210_104_20180925_00067.jpg

Looking west at concrete rubble on waterward shoulder and slope.

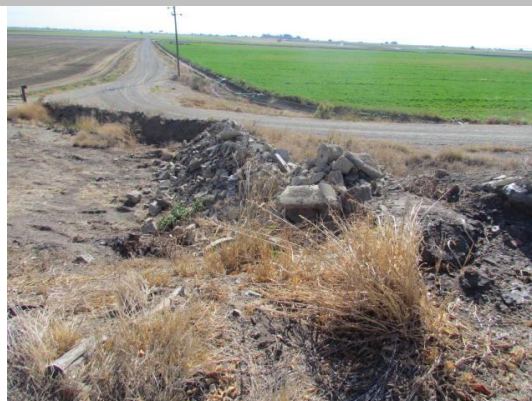
Photo 2 of 2 : FA_2018_RD0563_210_104_20180925_00068.jpg

Looking east at concrete rubble on landward slope.

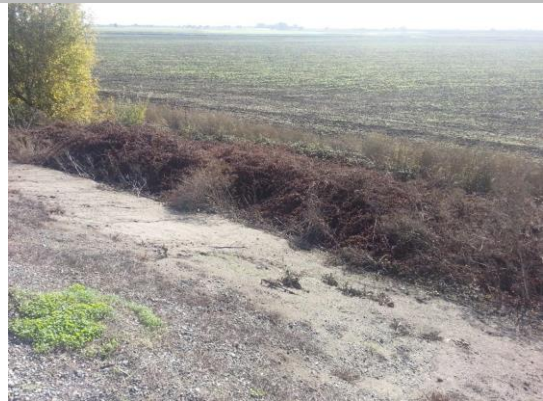
Photo 2 of 2 : FA_2018_RD0563_210_67_20180925_00025.jpg

Looking east at dead berryvines at landward toe. (Fall 2016)

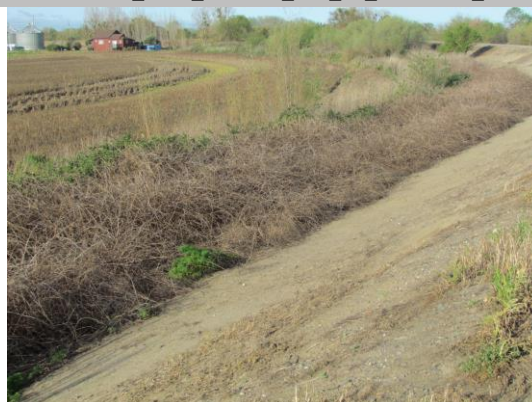
Photo 1 of 5 : FA_2018_RD0563_210_74_20180925_00033.jpg

Looking southeast at dead berryvines along landward toe and berm.
(Spring 2017)

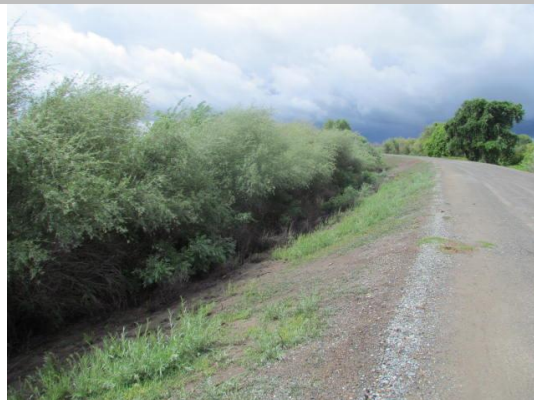
Photo 5 of 5 : FA_2018_RD0563_210_74_20180925_00037.jpg

Looking south at dense vegetation at landward slope and toe. (Spring 2015)

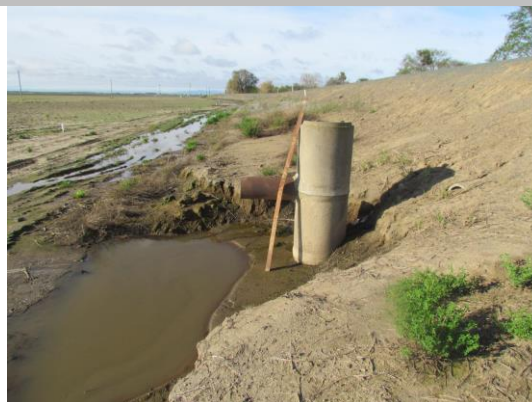
Photo 1 of 4 : FA_2018_RD0563_210_125_20180925_00086.jpg

Looking at erosion around stand pipe at landward toe.

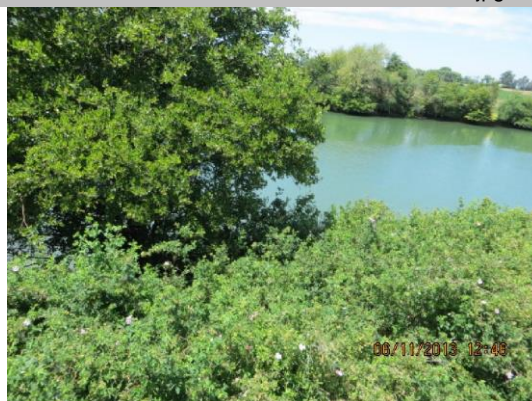
Photo 3 of 3 : UCIP_FA_2018_52763_24593.jpg

Unable to locate pump or other appurtances on WS toe due to vegetation.

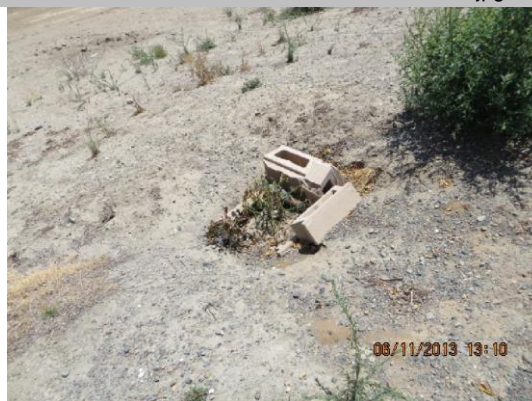
Photo 1 of 3 : UCIP_FA_2018_14950_24607.jpg

Vent/filler pipe exposed on LS shoulder.

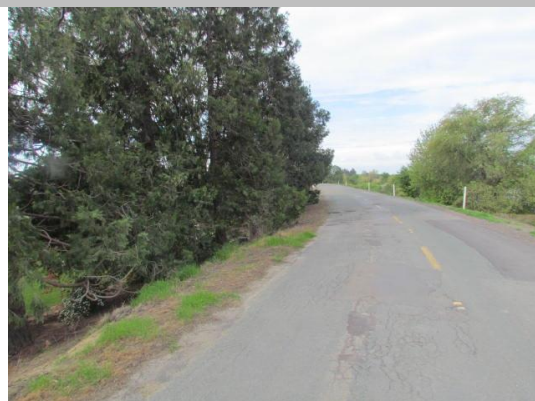
Photo 1 of 1 : FA_2018_RD0563_210_23_20180925_00012.jpg

Looking south at trees on landward shoulder.

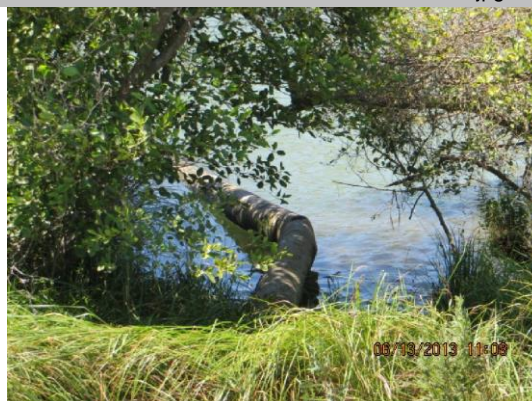
Photo 1 of 3 : UCIP_FA_2018_16292_27453.jpg

Pipe visible on WS toe. See damage to pipe at bend.

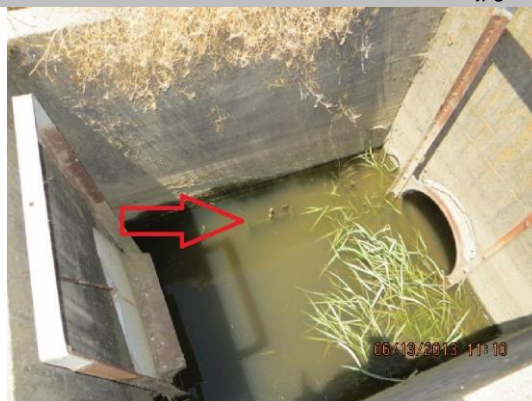
Photo 3 of 3 : UCIP_FA_2018_16292_27451.jpg

Broken slide gate in 7'x9' concrete distribution box on LS toe.

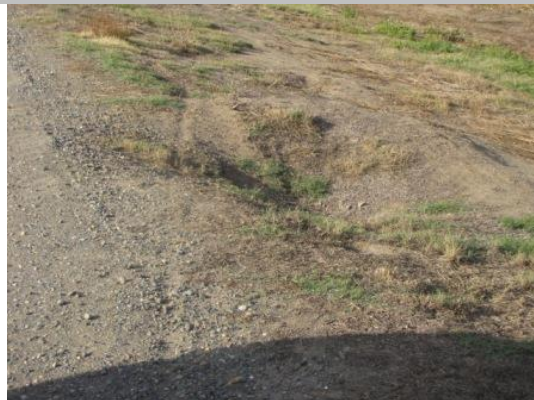
Photo 1 of 4 : FA_2018_RD0563_210_76_20180925_00039.jpg

Looking northeast a depression on landside shoulder and slope above 10" irrigation pipe four feet below crown.

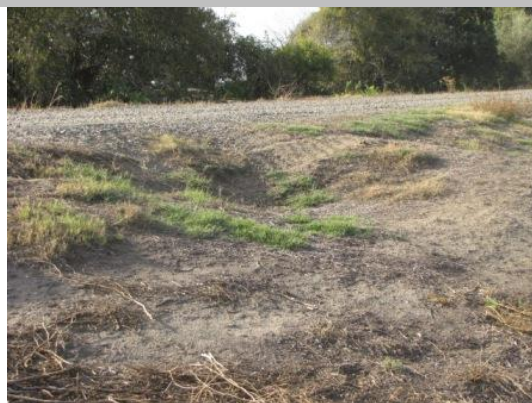
Photo 4 of 4 : FA_2018_RD0563_210_76_20180925_00042.jpg

Looking west at depression on landside shoulder and slope.
